TECH TIP

MERCURY VILLAGER/NISSAN QUEST

NO REAR BLOWER OPERATION

Year Models: 1993-1997

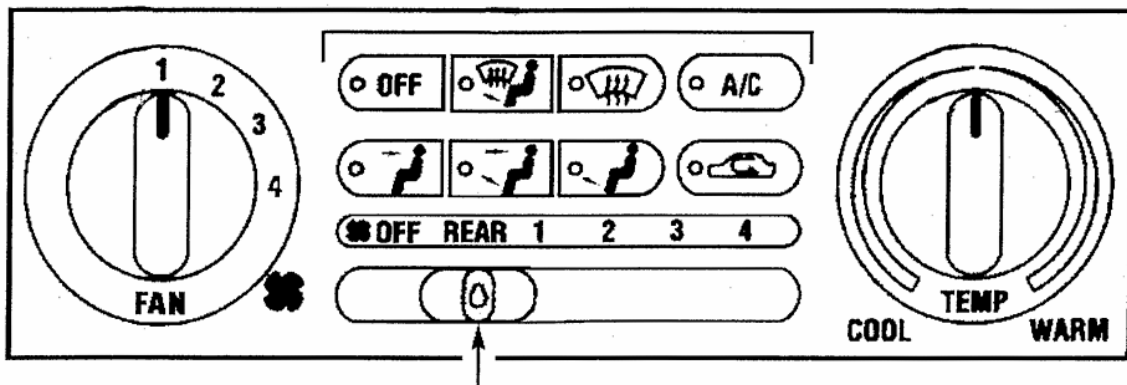
Rear Blower Switch on
Front HVAC Control Panel

Remove the front HVAC control panel. Insure that the blower switch, for the rear blower motor, is either in the “REAR” position or on one of the speed selections. Next, check continuity between the wires of the two-pin connector (ground circuit) while still connected to the control panel.

If continuity does not exist, remove the top cover of the HVAC control panel. Carefully check the printed circuit board for cracks or a broken solder joint. A broken solder joint can generally be found near one of the corners.

Two possible repairs may be done. If only the solder joint is broken, re-solder the joint (Do Not use acid core solder). Should the circuit board be cracked beyond repair, replace the HVAC control panel with a new assembly.
