## TECH TIP

### AIR GAP ON SOME TOYOTAS

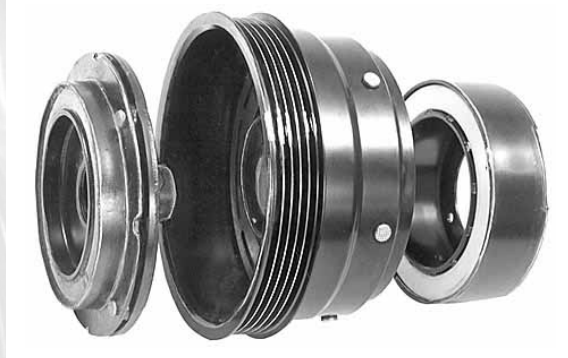
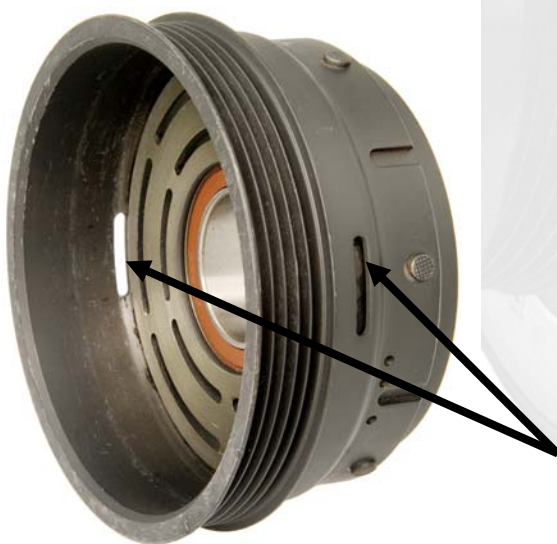
When the hub fits inside the pulley as it does with clutch part numbers: 48596, 48820, 48822, and 48827, it seems that you can't check the air gap.

Toyota has made checking the air gap a cinch by placing slots in the pulley.

The air gap is adjusted by adding or removing shims. The specification for this air gap is .016 to .030 inch.
