TECH TIP

Checking Those Switches

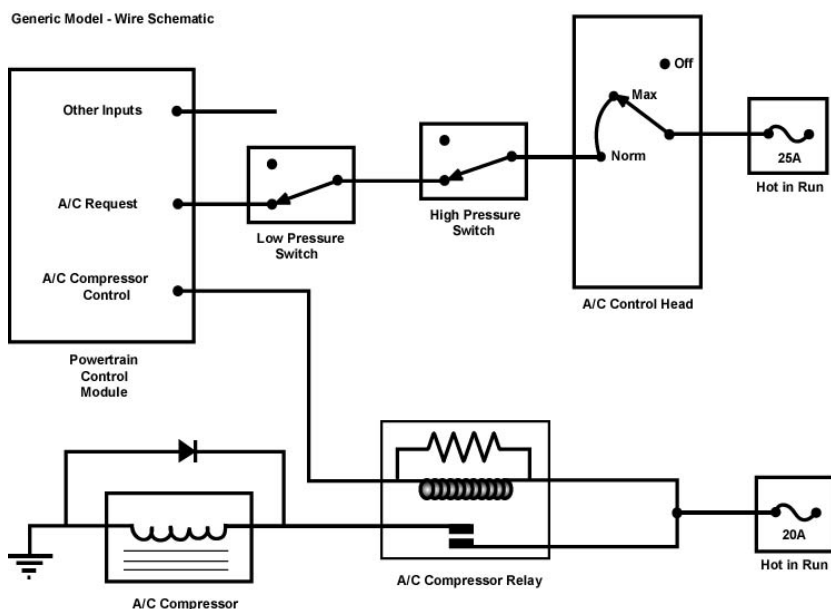
In the wiring diagram shown below a positive voltage signal is sent from the *A/C control head* to the high-pressure switch. The high-pressure switch should be closed below 400-psi, which will allow the signal to pass on to the low-pressure switch. If there is sufficient refrigerant pressure (minimum of 40-psi) at the low-pressure switch, the signal will pass through the low-pressure switch where it will be received by the PCM. After the PCM receives this signal, it processes this information and checks to see if all other input sensors are within specifications before proceeding. If everything passes, the PCM will supply a ground signal to the *compressor clutch control relay* which will then engage the compressor clutch.

With the customer's vehicle the scanner revealed no A/C request to the PCM. So the no clutch operation could be due to a faulty low-pressure switch or a faulty high-pressure switch. Use a fused (10amp) jumper wire to bypass each switch individually. When the scan tool shows an A/C request then the problem has been isolated to the switch and/or harness connector. Further testing of these two components will be required to pinpoint the exact problem.
