TECH TIP

BLOWER MOTOR HUMMING NOISE

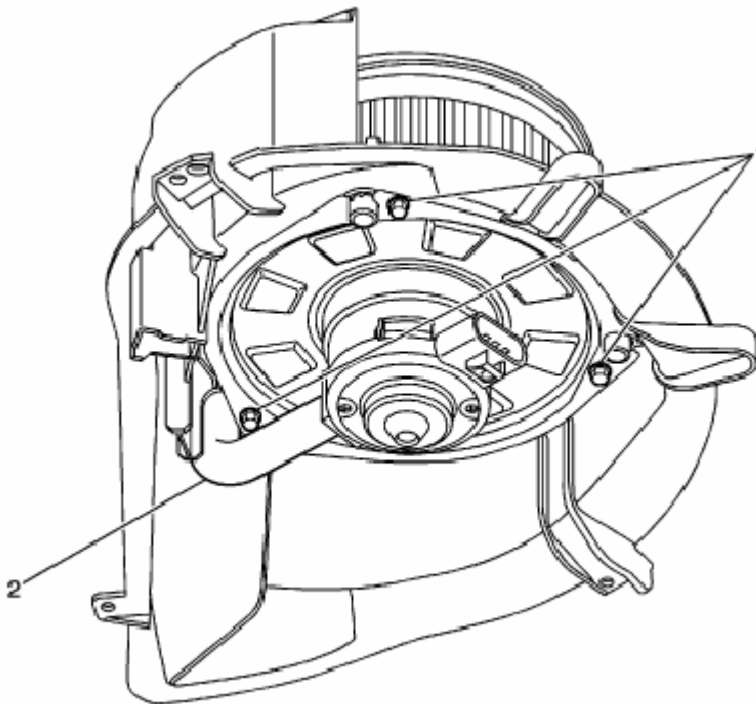
GM has determined that the most likely cause of the humming noise is from the positioning of the blower motor within the HVAC housing, causing a restriction of the incoming airflow. (GM tsb 03-01-37-001)

The recommended repair for this symptom is to reposition the blower motor.

- A. Remove the right side sound insulator.
- B. Loosen the three blower motor retainer bolts. (Do not remove bolts) #1
- C. Shift motor as far as allowed toward the vent tube. #2
- D. Re-tighten the retainer bolts.
- E. Re-install right side sound insulator.
